***The Sandown Depot
in
Photographs***

Existing Conditions Plans

Report Appendix

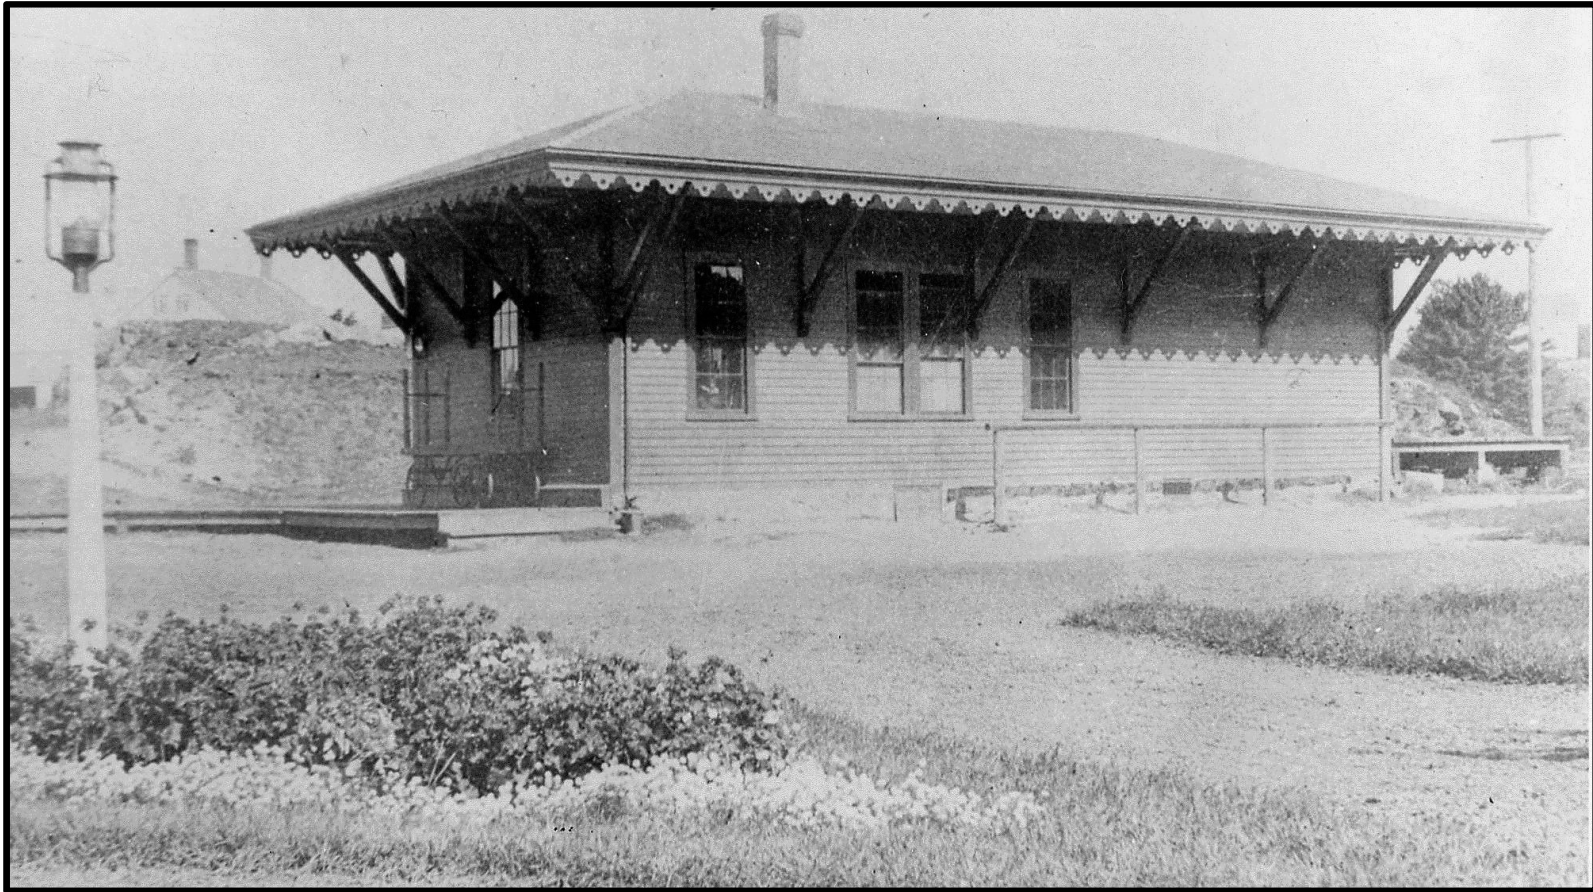
Image Number 2

***A nineteenth century image showing the south rear face of the building.
Note the early window locations and hitching rail for horses.***

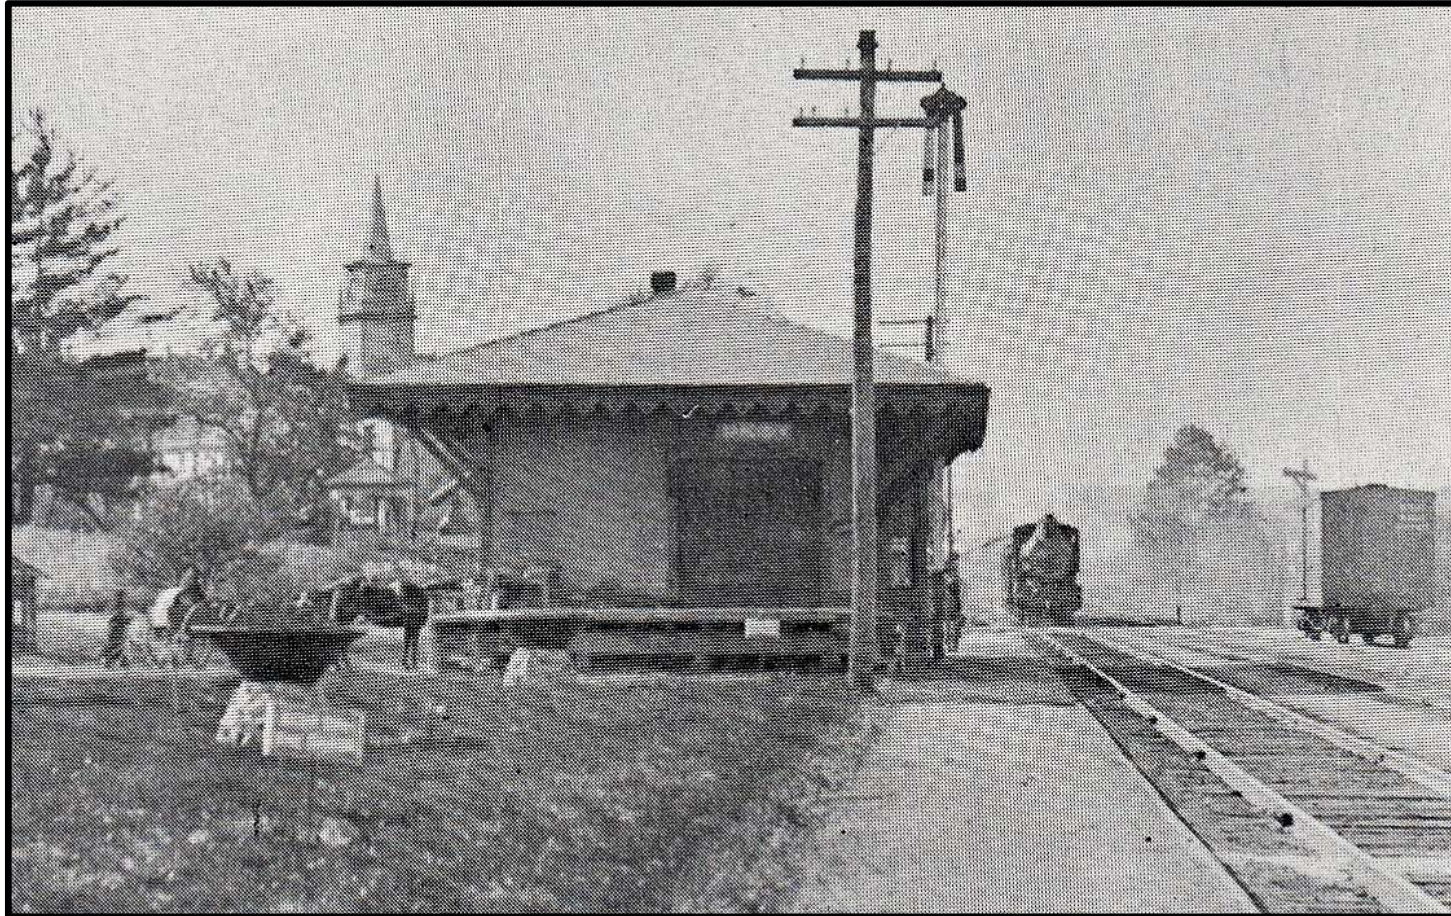
Image Number 4

***The east side of the building looking west circa 1915.
Note the presence of the raised loading dock and freight room sliding door.***

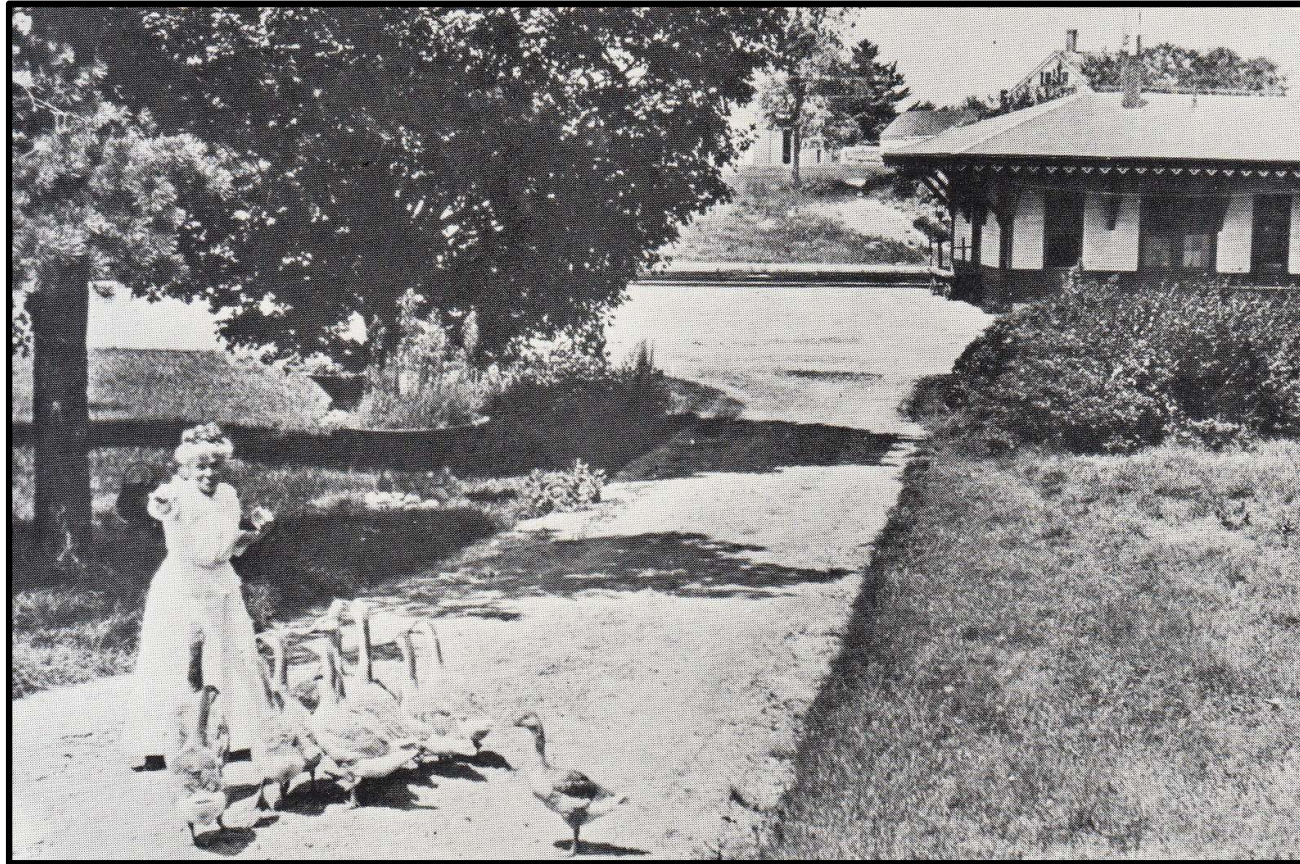
Image Number 5

***Station Agent George Sanborn's wife Lisette with her geese circa 1900.
Note the original window locations in the rear wall of the depot building beyond.***

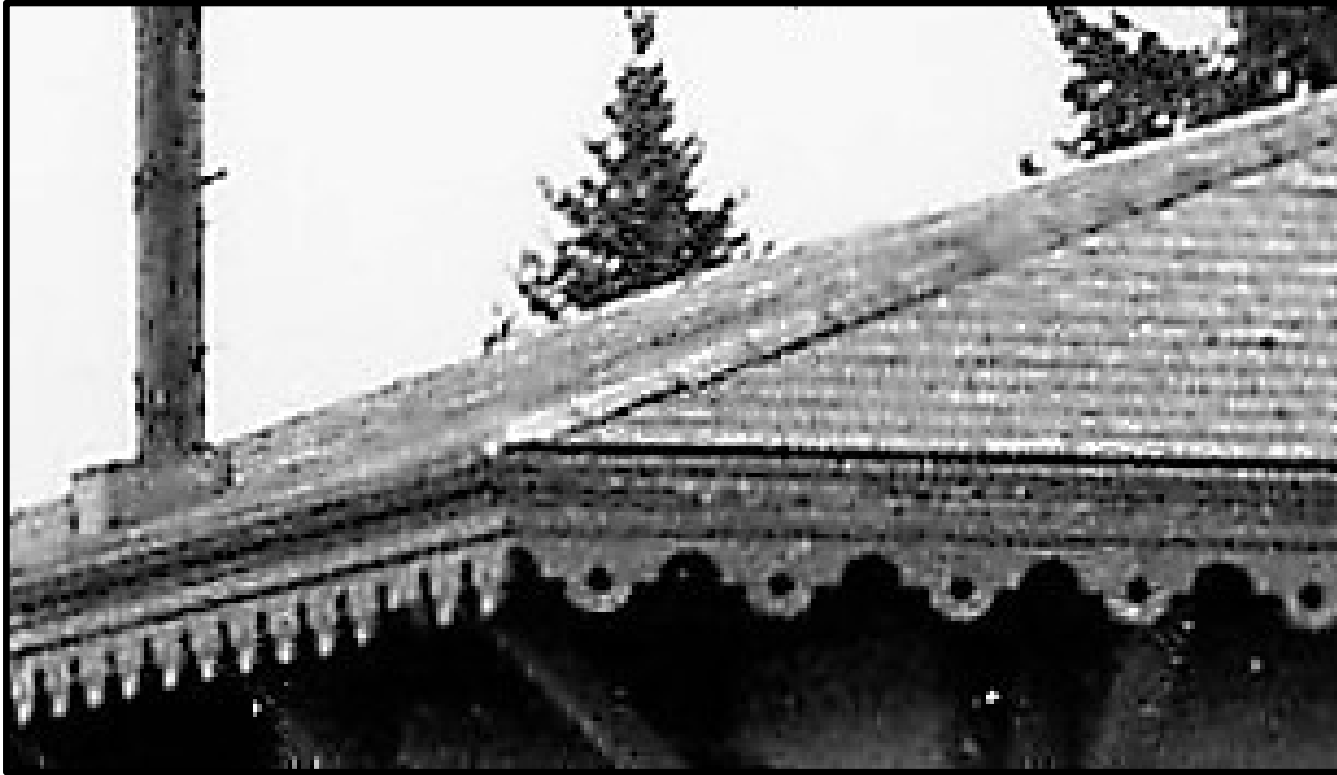
Image Number 6

Roof edge detail enlargement from a 1938 image of the building.

Note roof eave bargeboard detail and what appears to be slate roof shingles and the hips capped with individual formed pieces made from either sheet metal or copper.

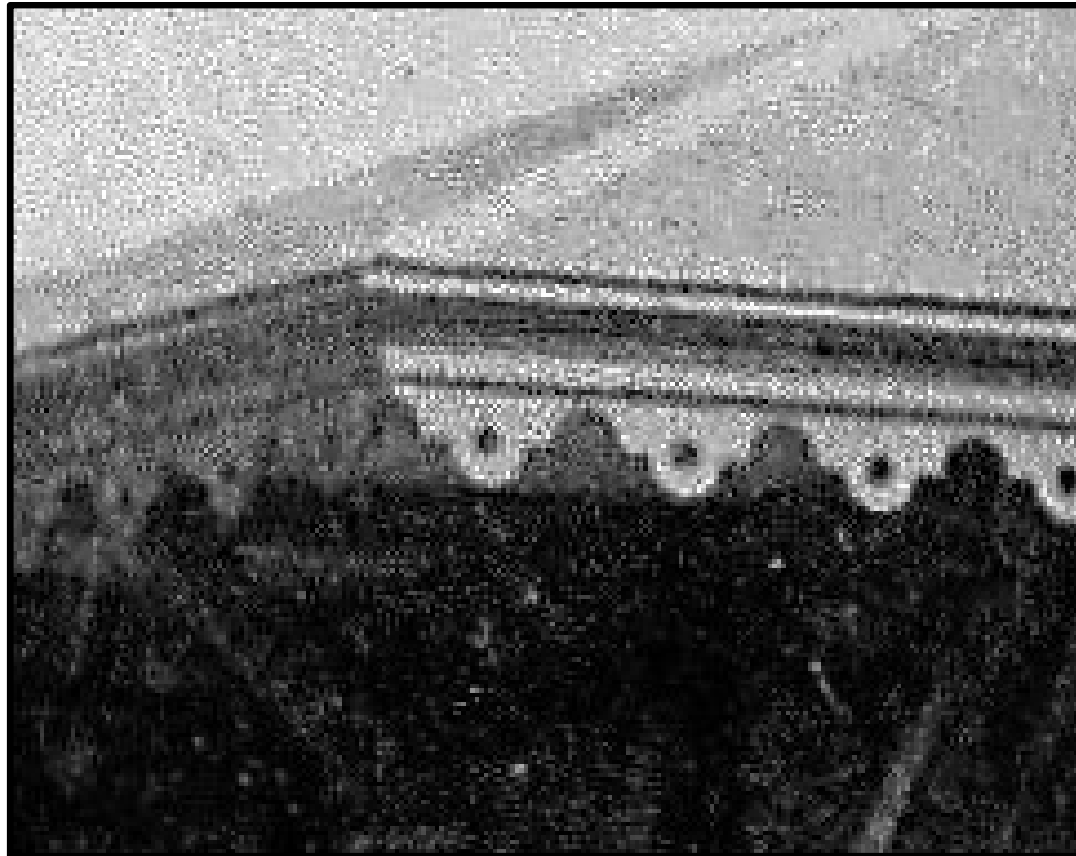
Image Number 7

Original roof eave and bargeboard detail

This is an enlargement made from Image Number 2.

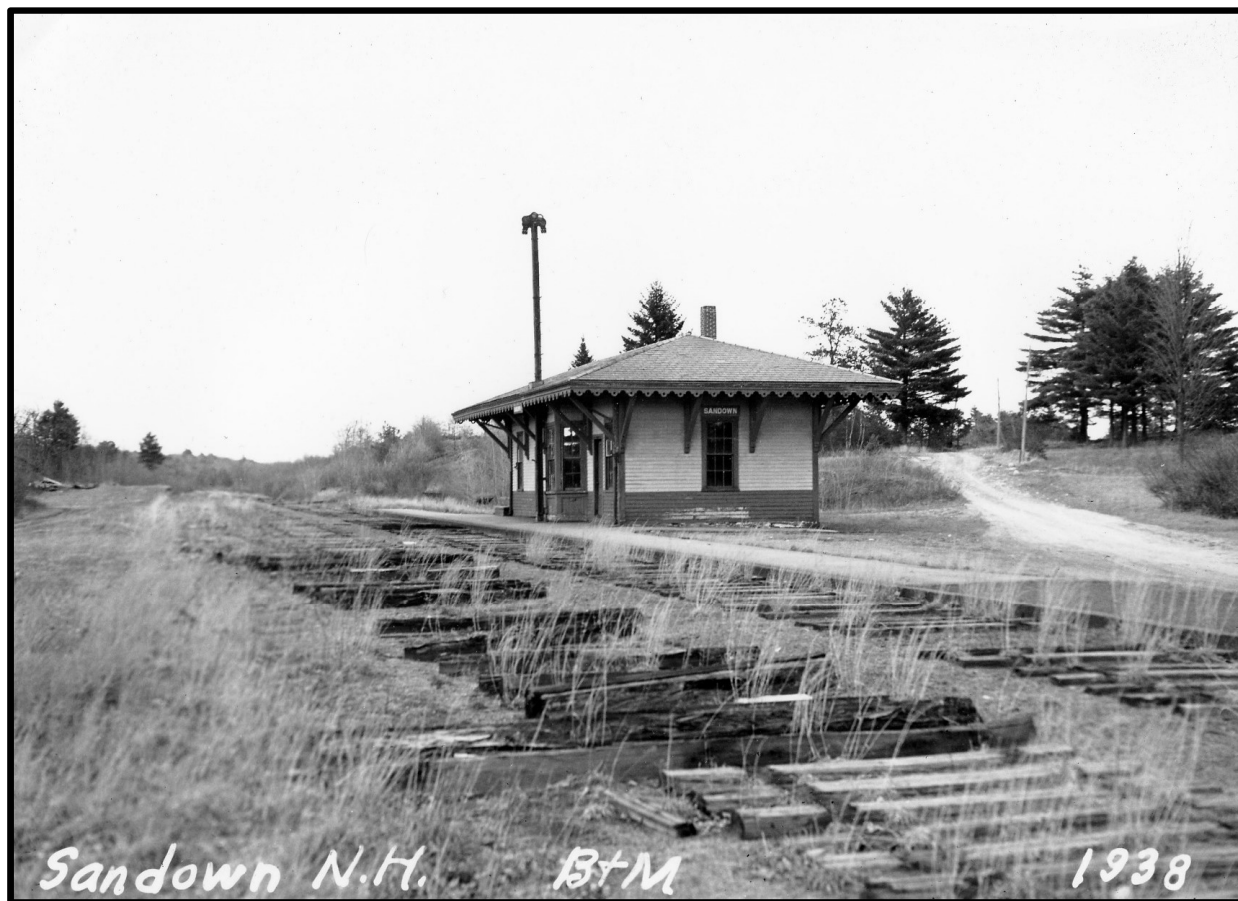
Image Number 8

***The Sandown Depot as it appeared in 1938 after the tracks had been pulled.
Note that the building still appears largely intact on the exterior with original roofing and trim.***

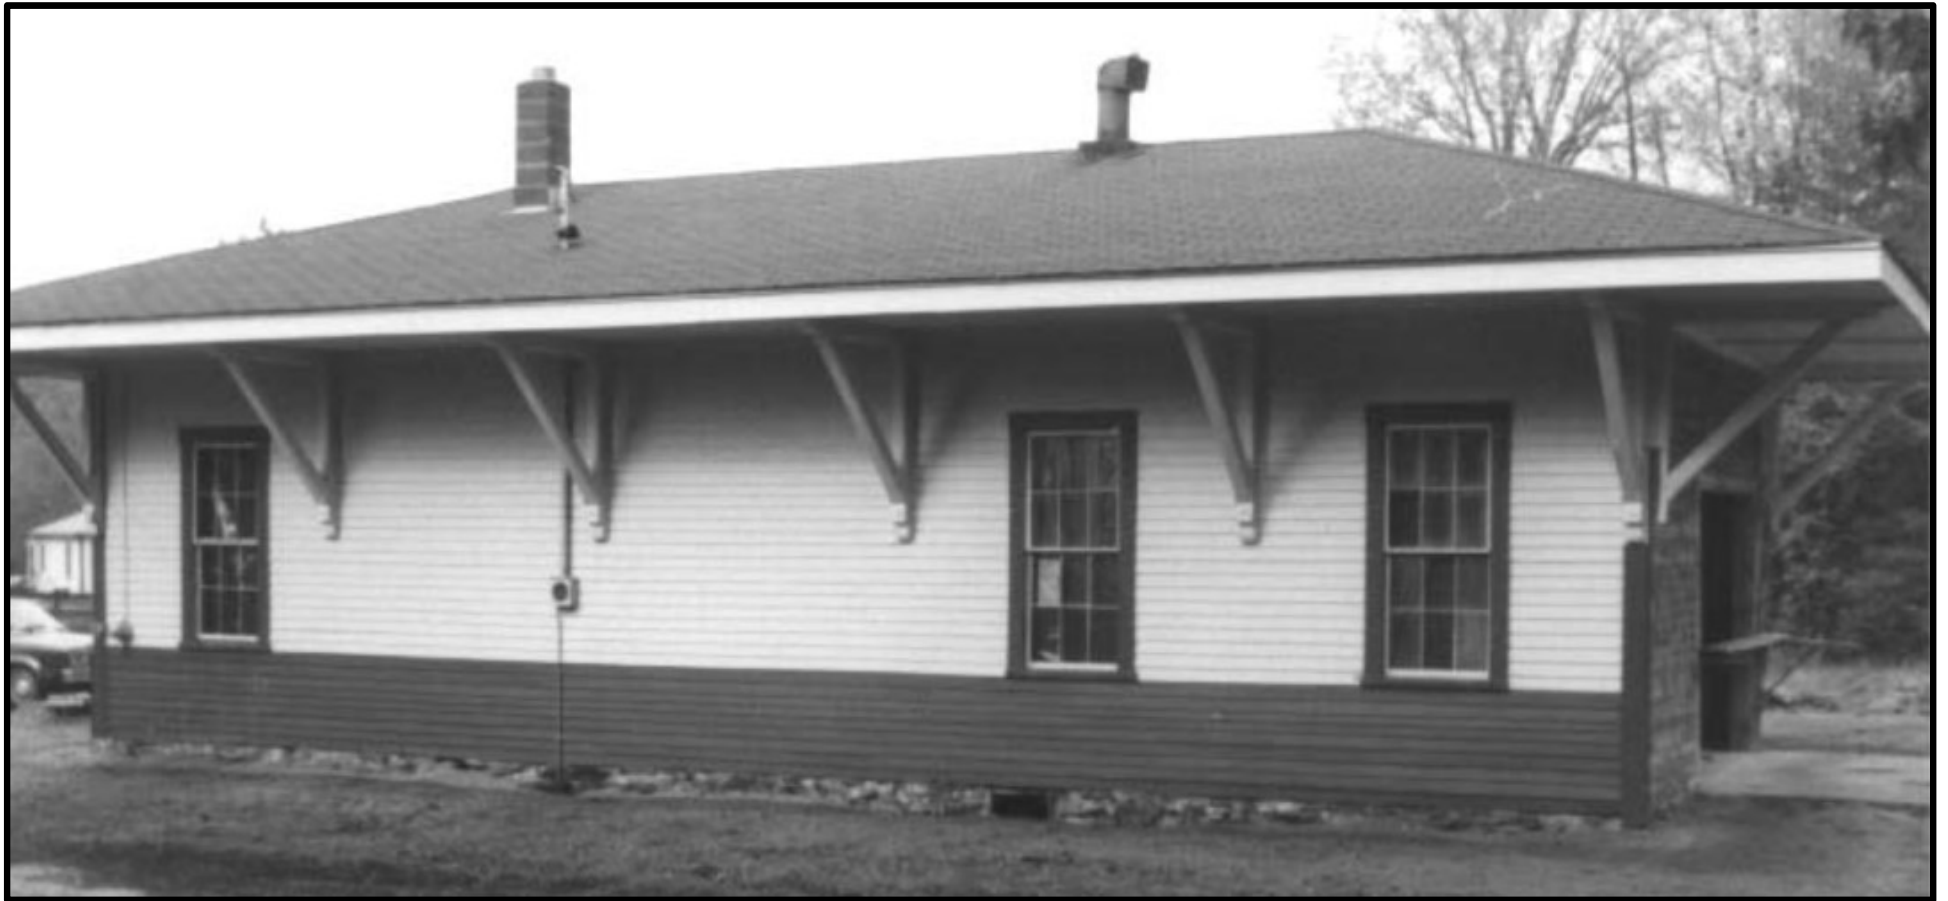
Image Number 10

South rear elevation of the building circa 1977 showing altered window locations and modified east end wall.

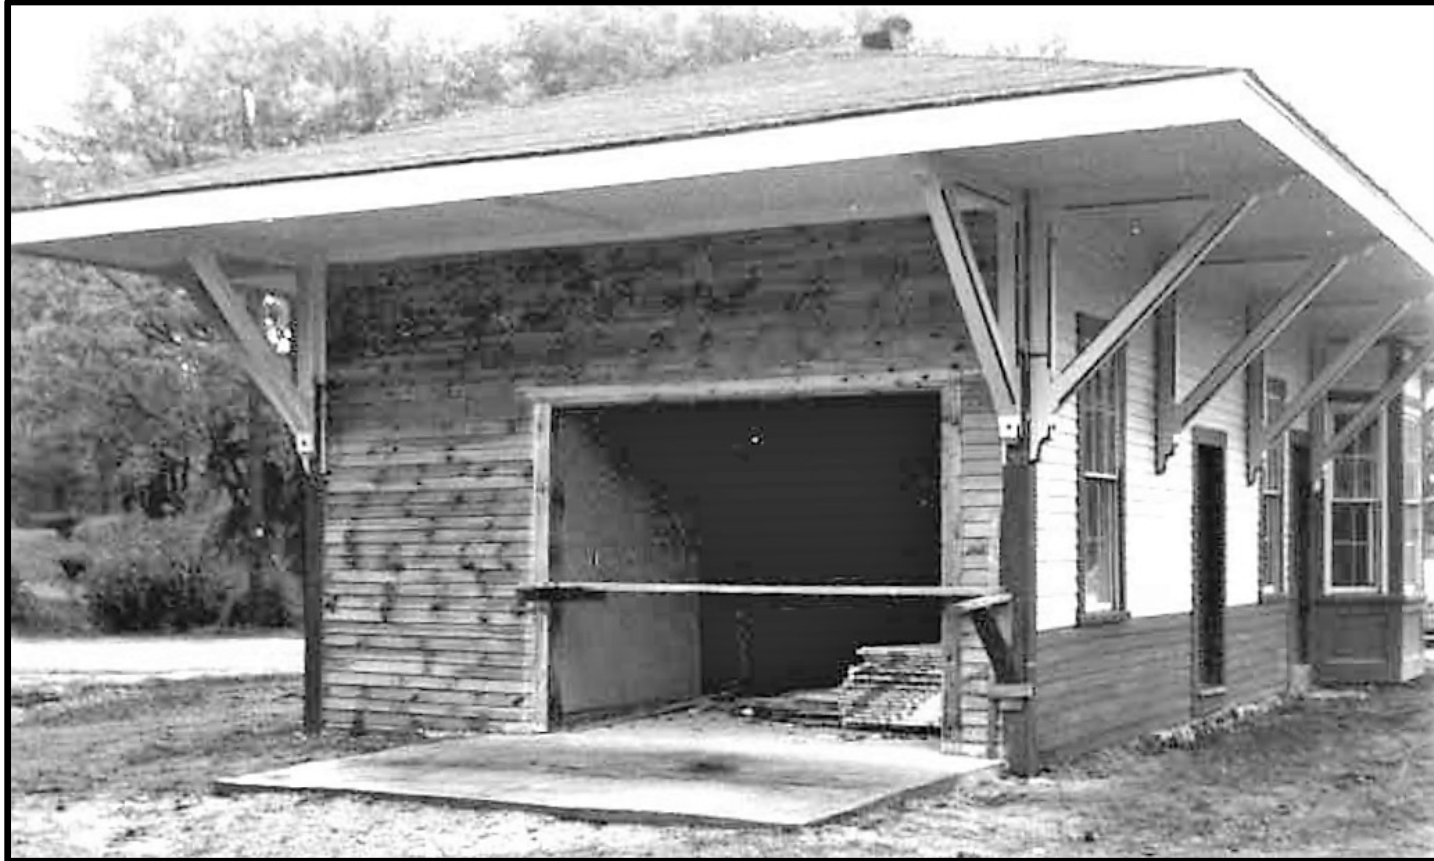
Image Number 11
***East end wall elevation circa 1977 showing post railroad
highway garage modifications.***

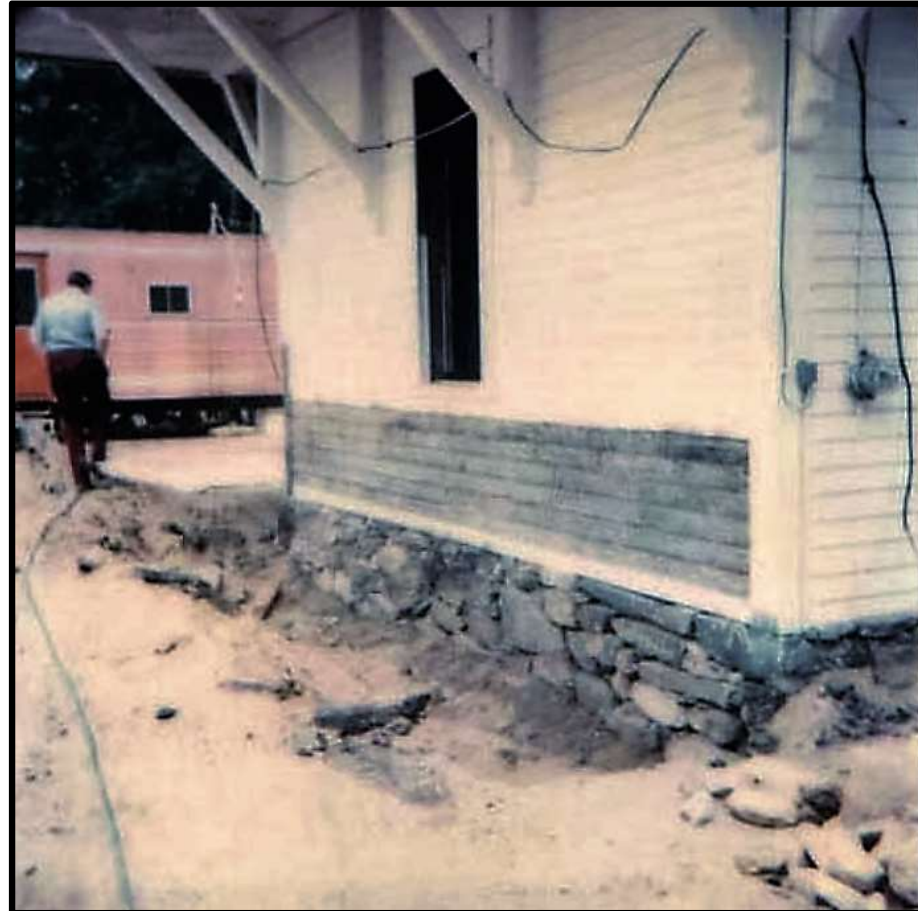
Image Number 13
West end elevation circa 1977 showing original rubble stone foundation masonry.

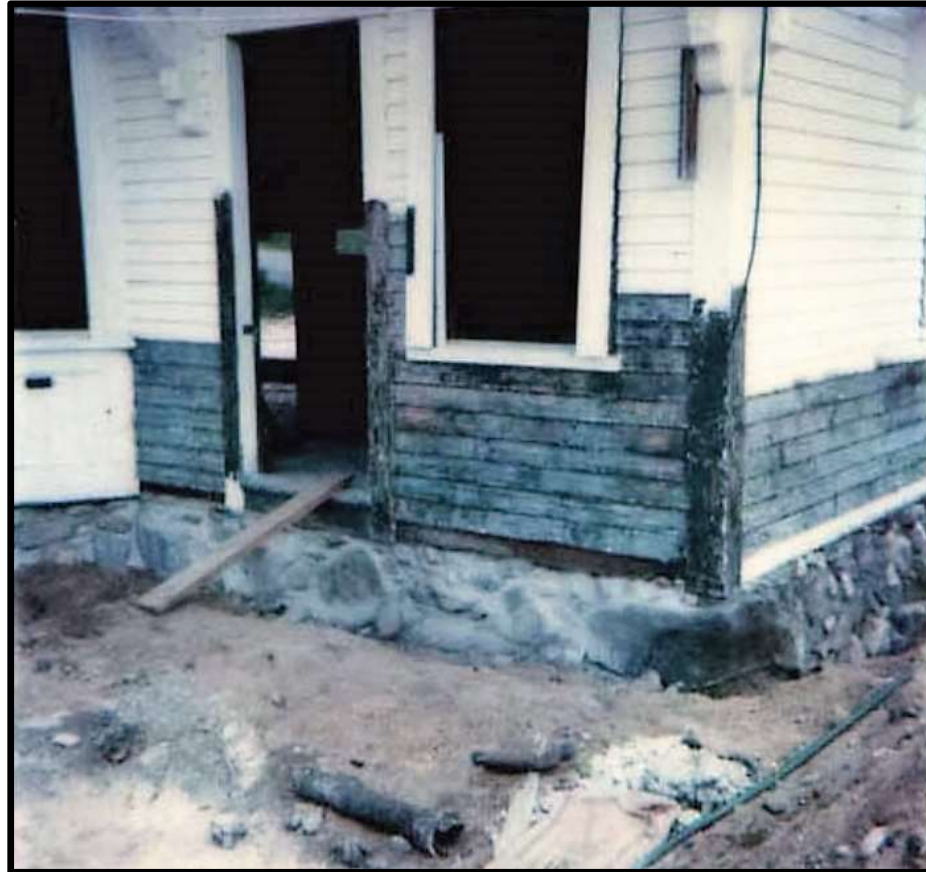
Image Number 14
Northwest corner foundation detail circa 1977.
